Operating Experience Weekly Summary 97-04

January 17 through January 23, 1997

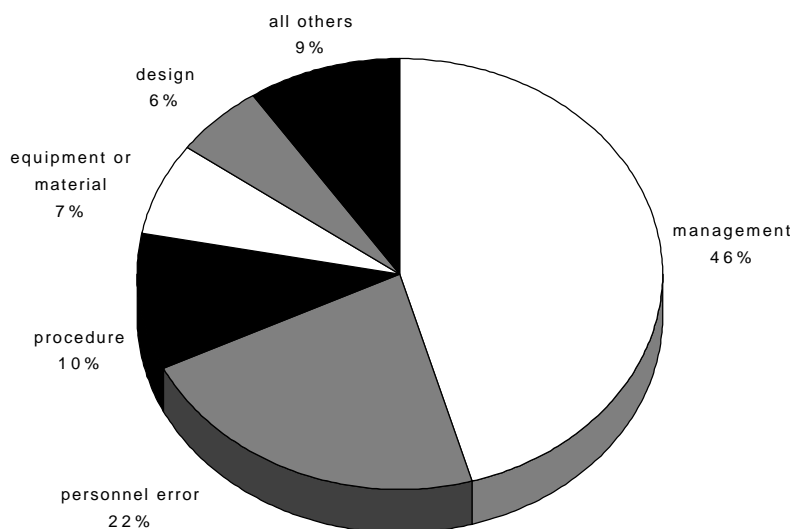
Figure 2-1. Distribution of Root Causes for Personnel Exposures¹

Operating Experience Analysis and Feedback (OEAF) engineers reviewed the Occurrence Reporting and Processing System (ORPS) database for exposures and found 126 events. Figure 2-1 shows the distribution of root causes for these events.

Management problems contributed to 46 percent of root causes for personnel exposures. Table 2-1 shows a breakdown of the causal codes by percentage.

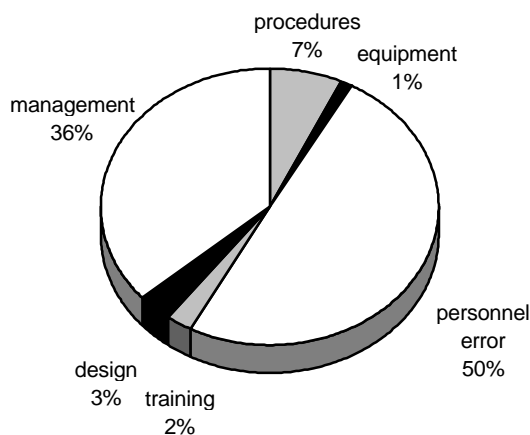
Figure 3-1. Distribution of Root Causes for Violation or Inadequate Procedures¹

Operating Experience Analysis and Feedback (OEAF) engineers reviewed the Occurrence Reporting and Processing System (ORPS) database for final reports between December 1995 and December 1996 with violation or inadequate procedures as the nature of occurrence and found 451 occurrences DOE-wide. Distribution of root causes for these occurrences is shown in Figure 3-1.

Personnel errors accounted for 50 percent of the events, and management problems contributed to 36 percent. A breakdown, showing the percentage of these cause codes, is shown in Table 3-1.

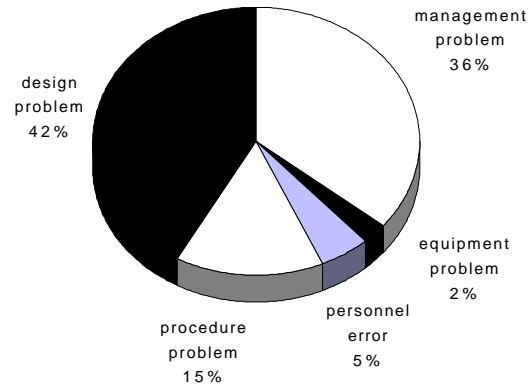
Figure 4-1. Root Causes for Electrical Shock or Near-Misses Attributed To Drawing, Specification, or Data Errors¹

Operating Experience Analysis and Feedback (OEAF) engineers reviewed the Occurrence Reporting and Processing System (ORPS) database and found 81 events reported DOE-wide where electrical shocks or near-misses were attributed to drawing, specification, or data errors. Figure 4-1 shows the distribution of root causes for these events and shows that the root cause of 36 percent of these events was reported as a management problem.

The causal code for design problems (drawing, specification, or data errors) contributed 88 percent of the overall design-related causes. Management problems contributed to 36 percent of the root causes for electric shock or near-misses attributed to drawing, specification, or data errors. Table 4-1 shows the breakdown of the causal codes by percentage.
